Report No. UT-02.17

***PAVEMENT AND
SUBGRADE DISTRESS –
REMEDIAL STRATEGIES
FOR CONSTRUCTION AND
MAINTENANCE (I-15
Mileposts 200-217)***

**By: Kyle M. Rollins, Ph.D
Ryan Christie**

**Utah Department of Transportation
Research Division**

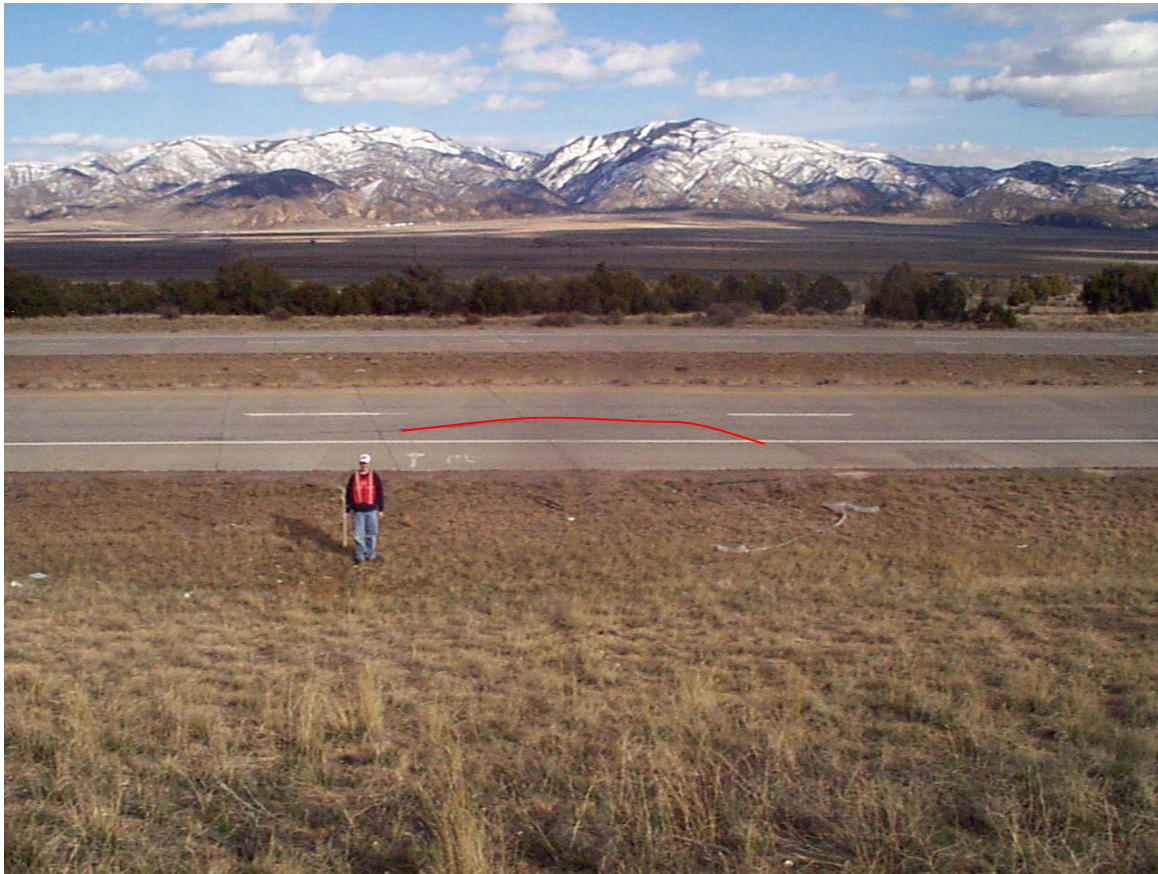
Figure 29: Longitudinal crack near Drill Hole 1, I-15, Juab County, UT.

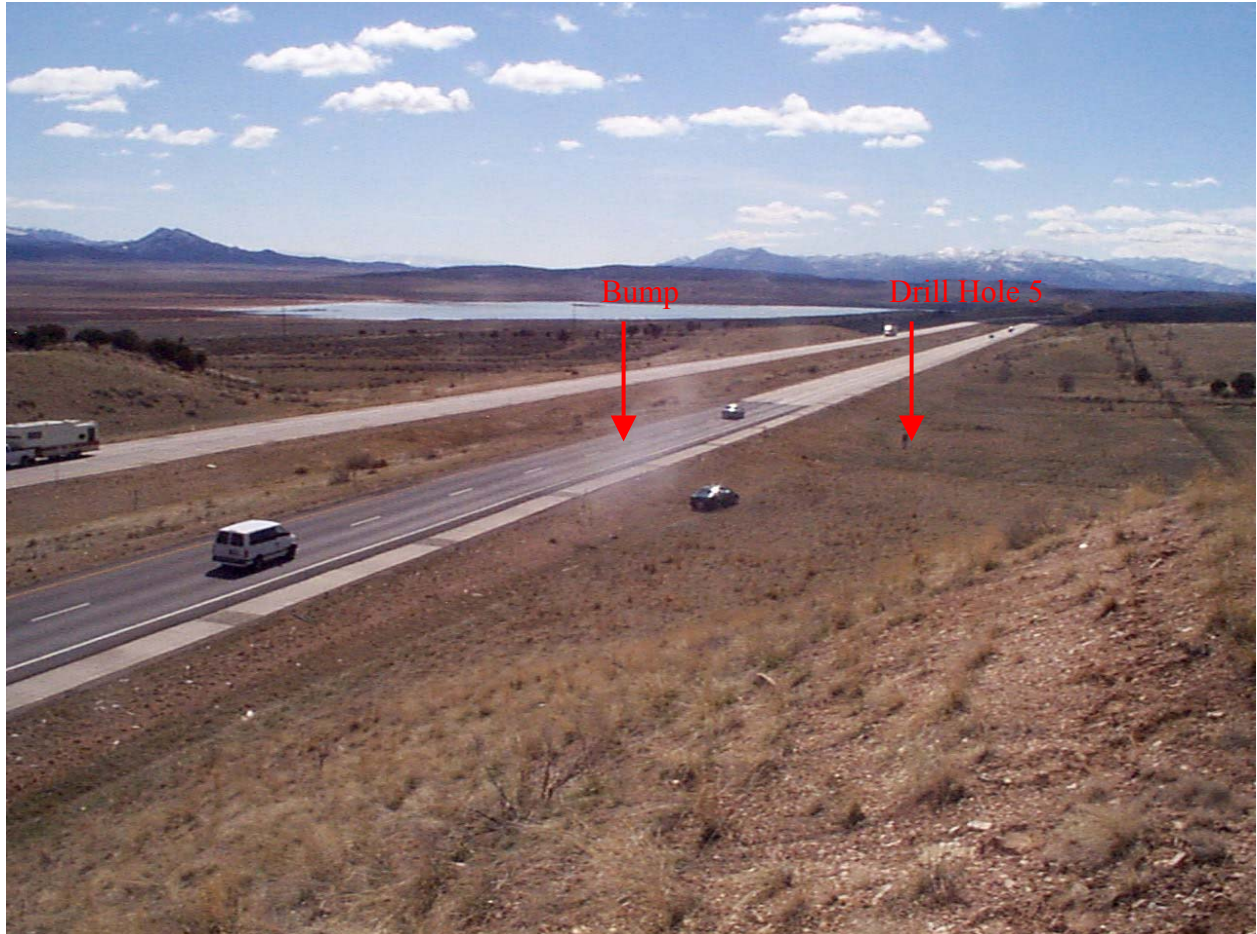
Figure 42: Elevated view of the area around Drill Hole 5, looking southeast. I-15 goes through the center of the picture. A bump can be seen in the repaired section on the freeway.

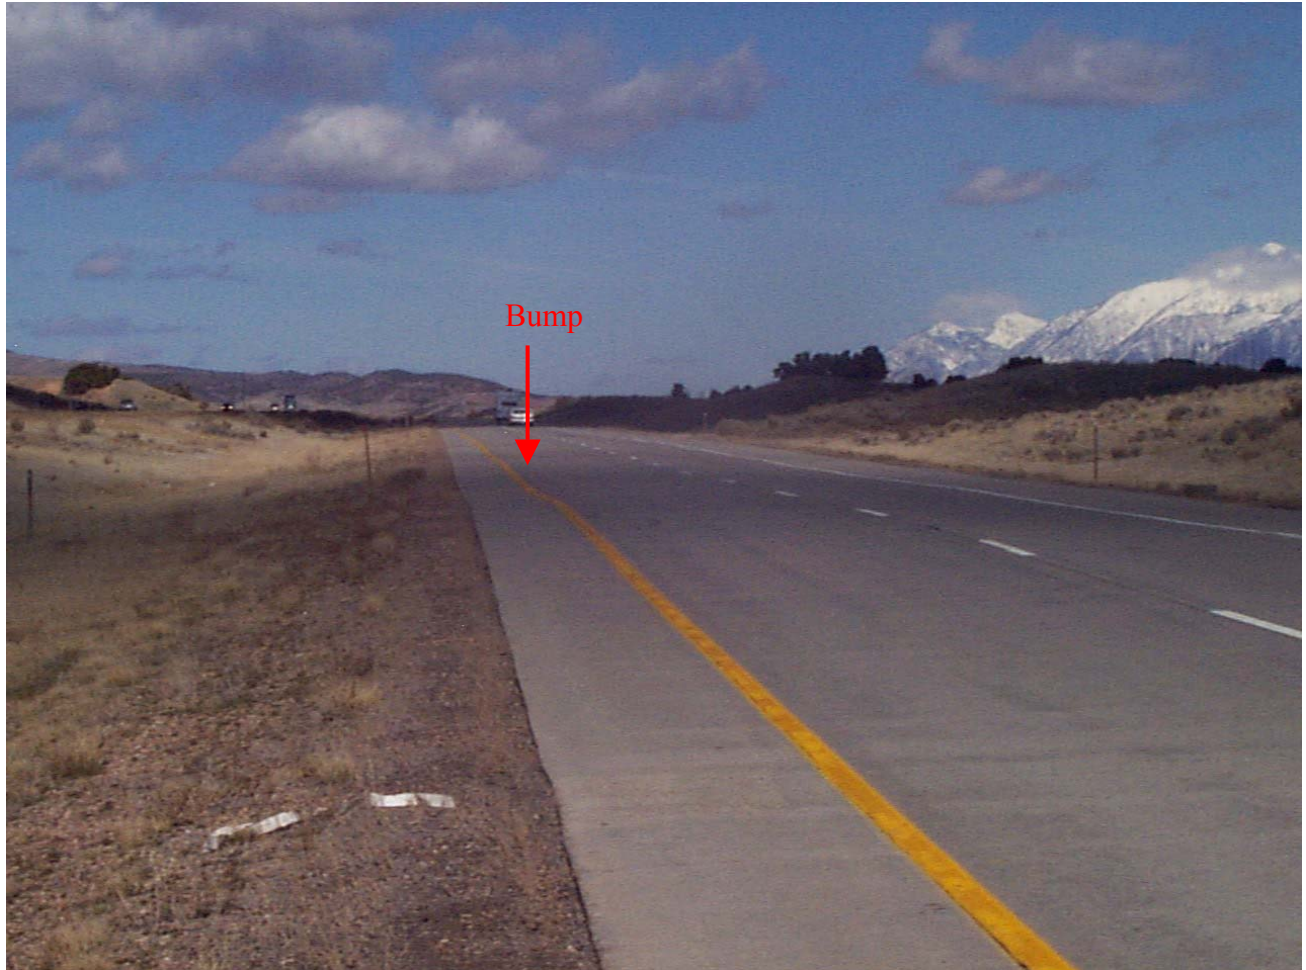
Figure 43: A significant bump can be seen on the northbound lanes of I-15 in the middle of the picture. This picture was taken looking north and Drill Hole 5 is to the west (not in picture).

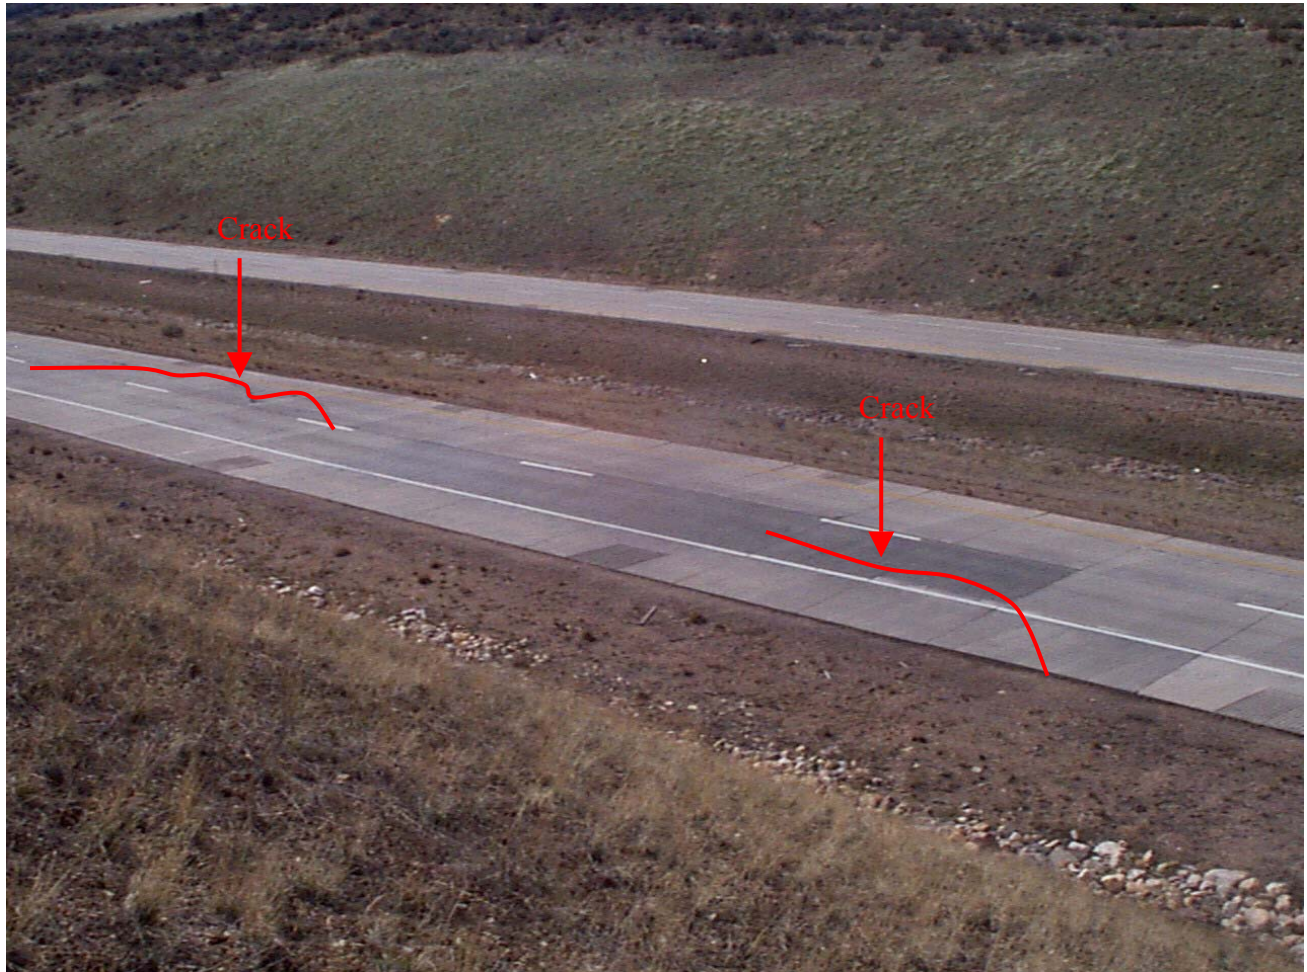
Figure 66: Looking southwest at the area around Drill Holes 7 and 8. There are two larger cracks along the northbound lanes of I-15 seen in this picture. The first is located in the upper $\frac{1}{4}$ of the lower right $\frac{1}{2}$ of the picture. The second is located in the lower $\frac{1}{4}$ of the upper left half of the picture.

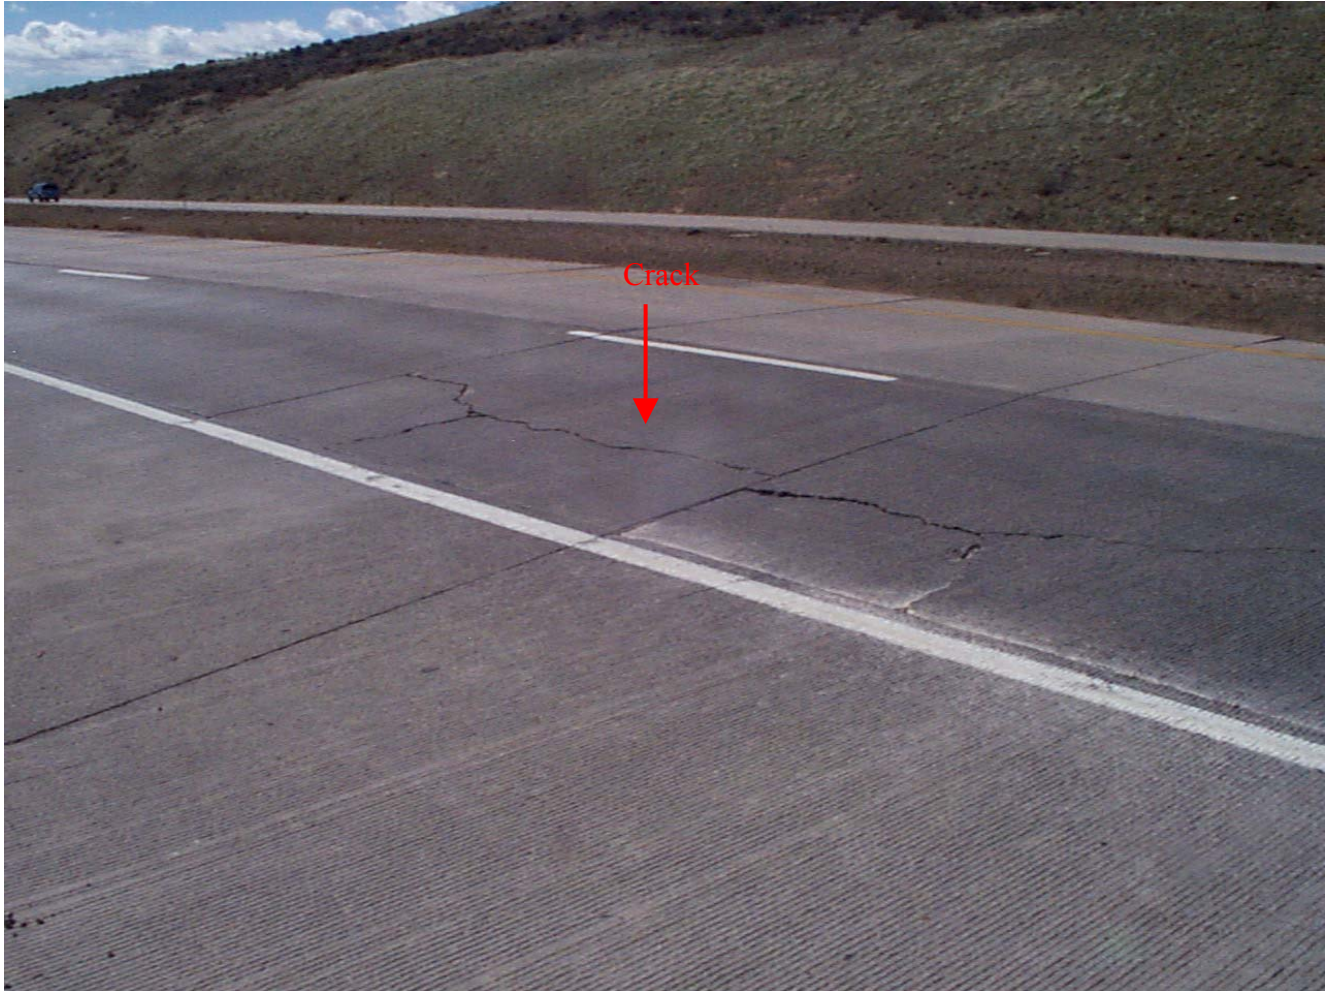
Figure 67: Cracking along the northbound lane of I-15 near Drill Holes 7 and 8. Close-up of Figure 66.

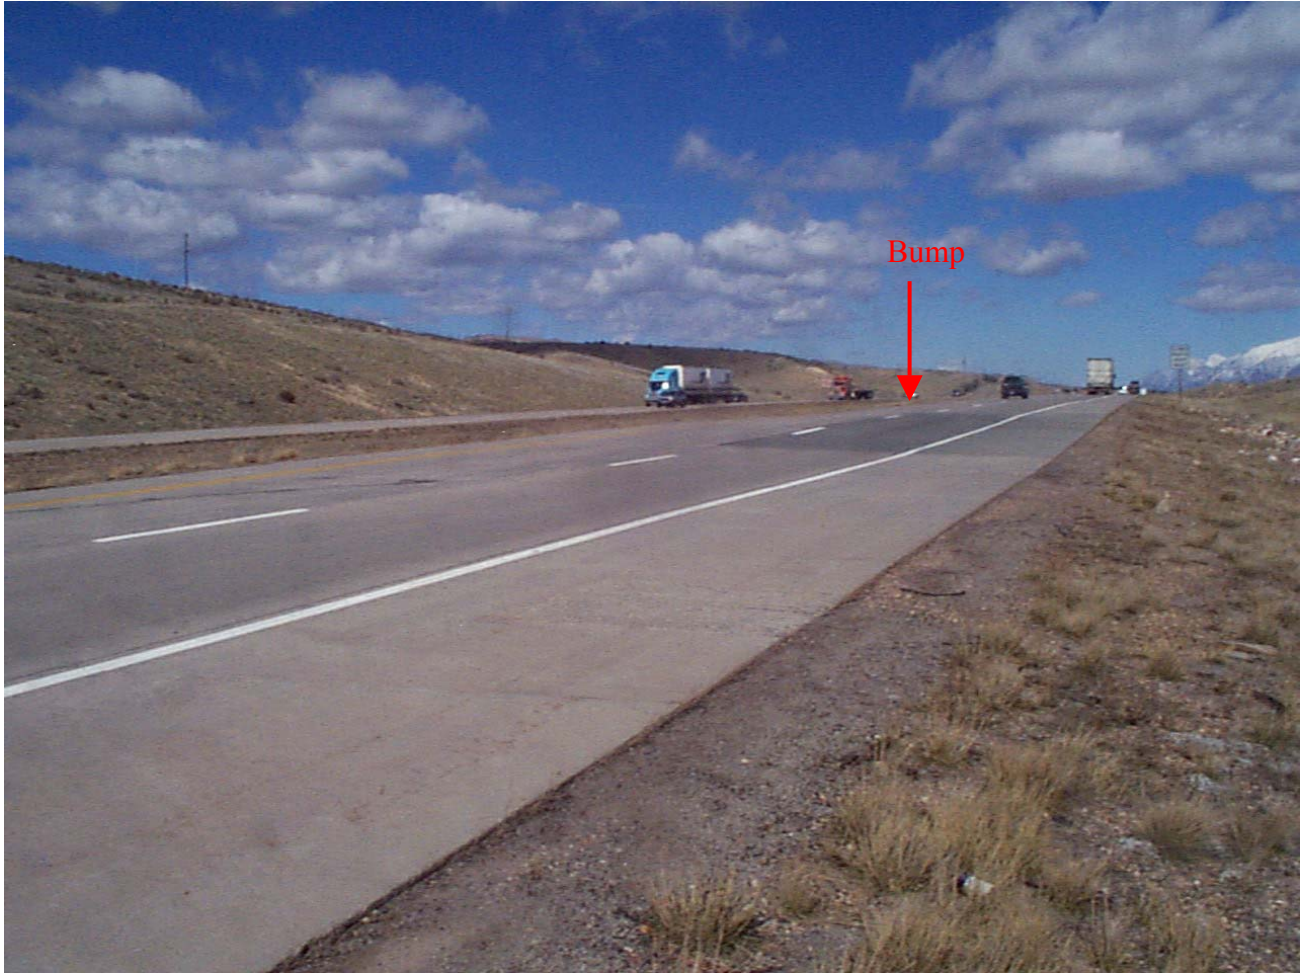
Figure 68: Large bump creating a danger for drivers spanning across the northbound lanes of I-15. This picture was taken looking north and is near Drill Holes 7 and 8.

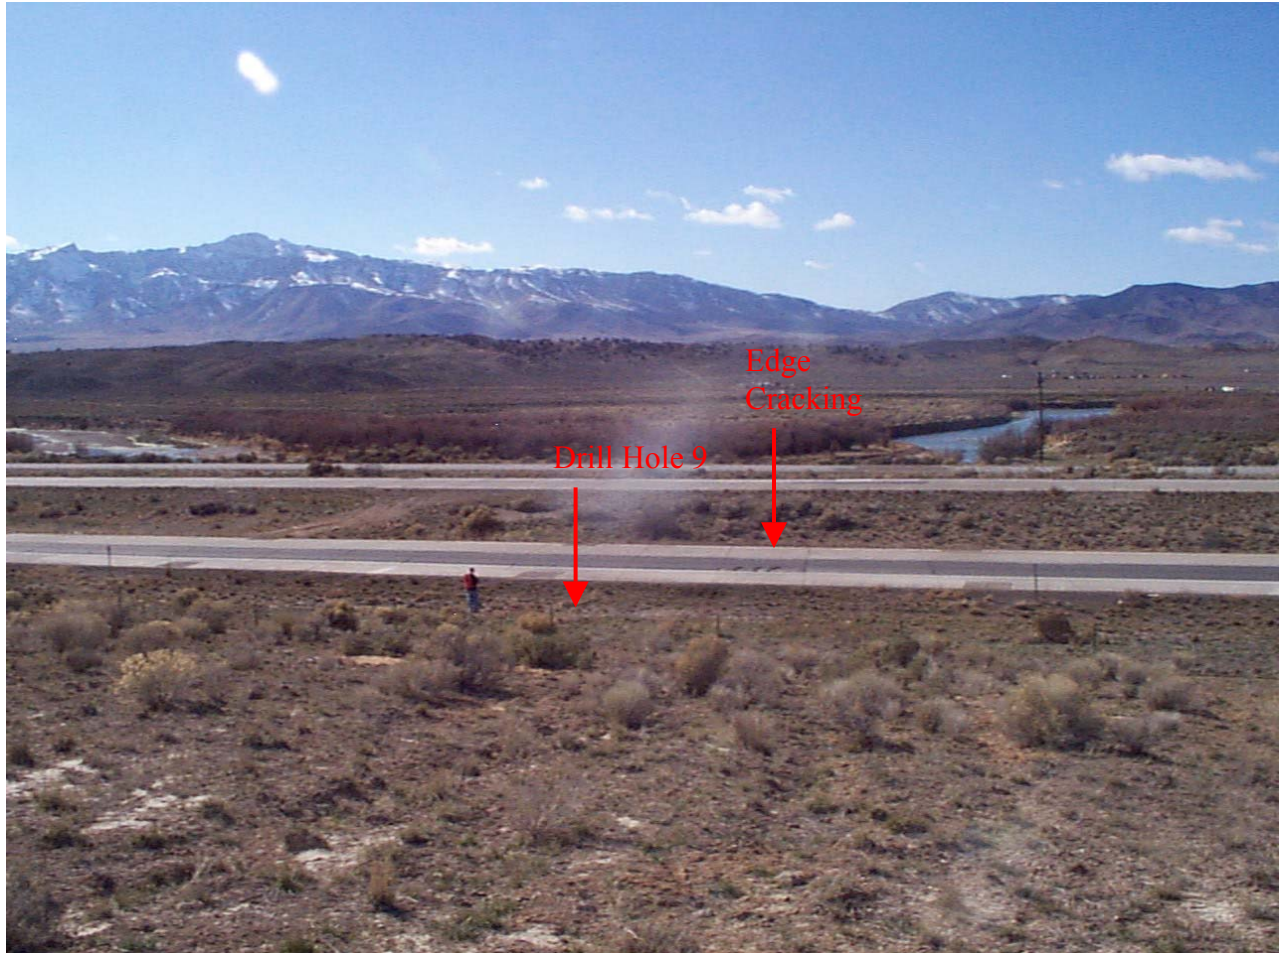
Figure 80: Looking west at the area around Drill Hole 9. Drill Hole 9 is located near the center of the picture where the person is standing. Damage along the edge of the northbound lanes of I-15 can be seen to the right of the standing person.

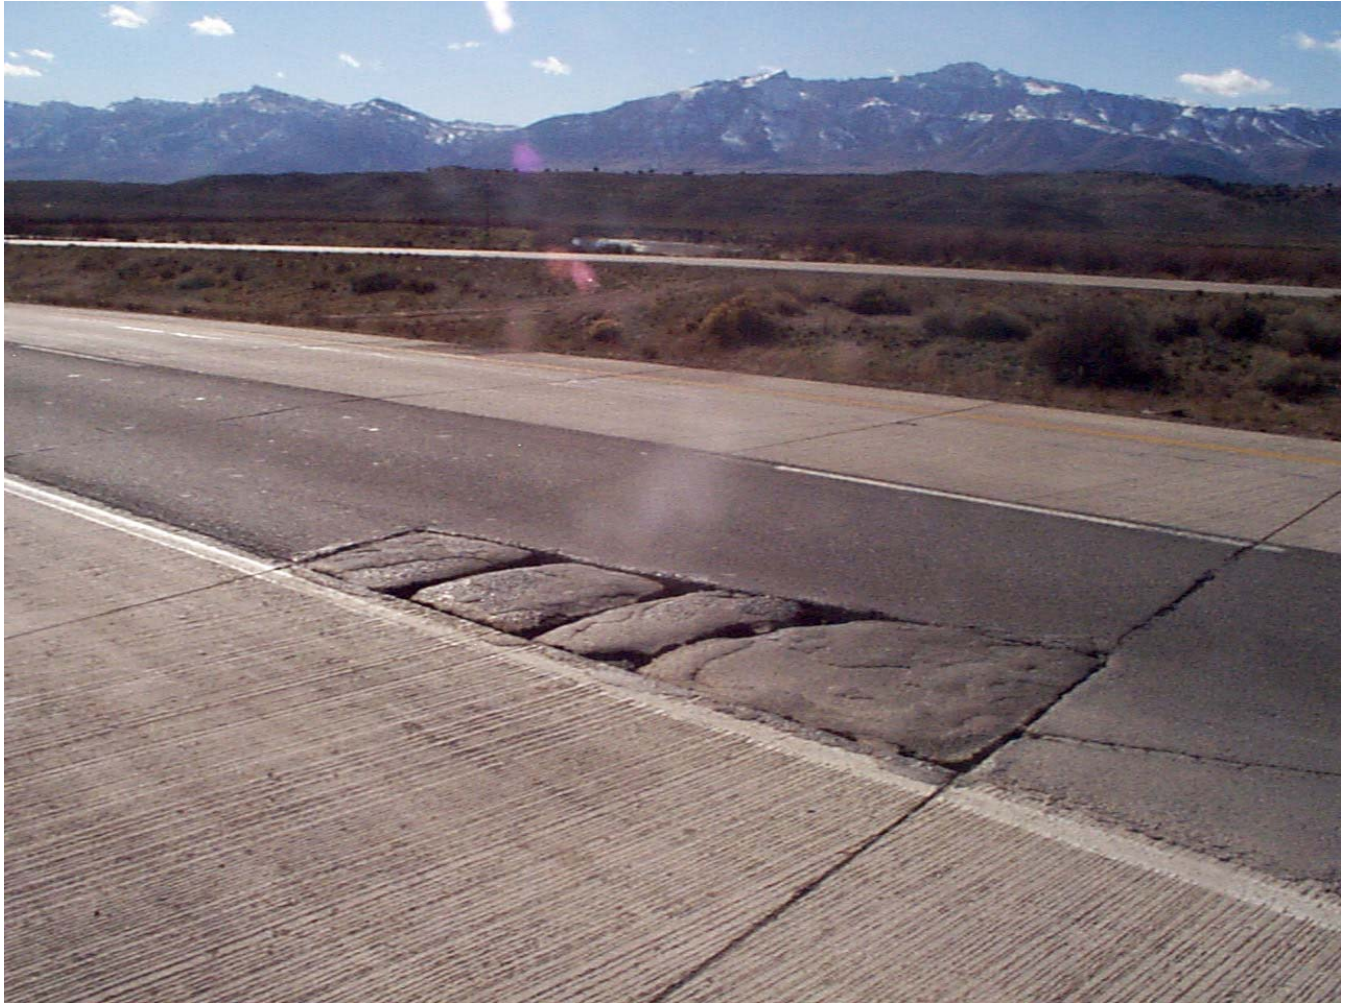
Figure 81: Edge damage along the northbound lane of I-15 about 0.45 miles south of milepost 201, next to Drill Hole 9.

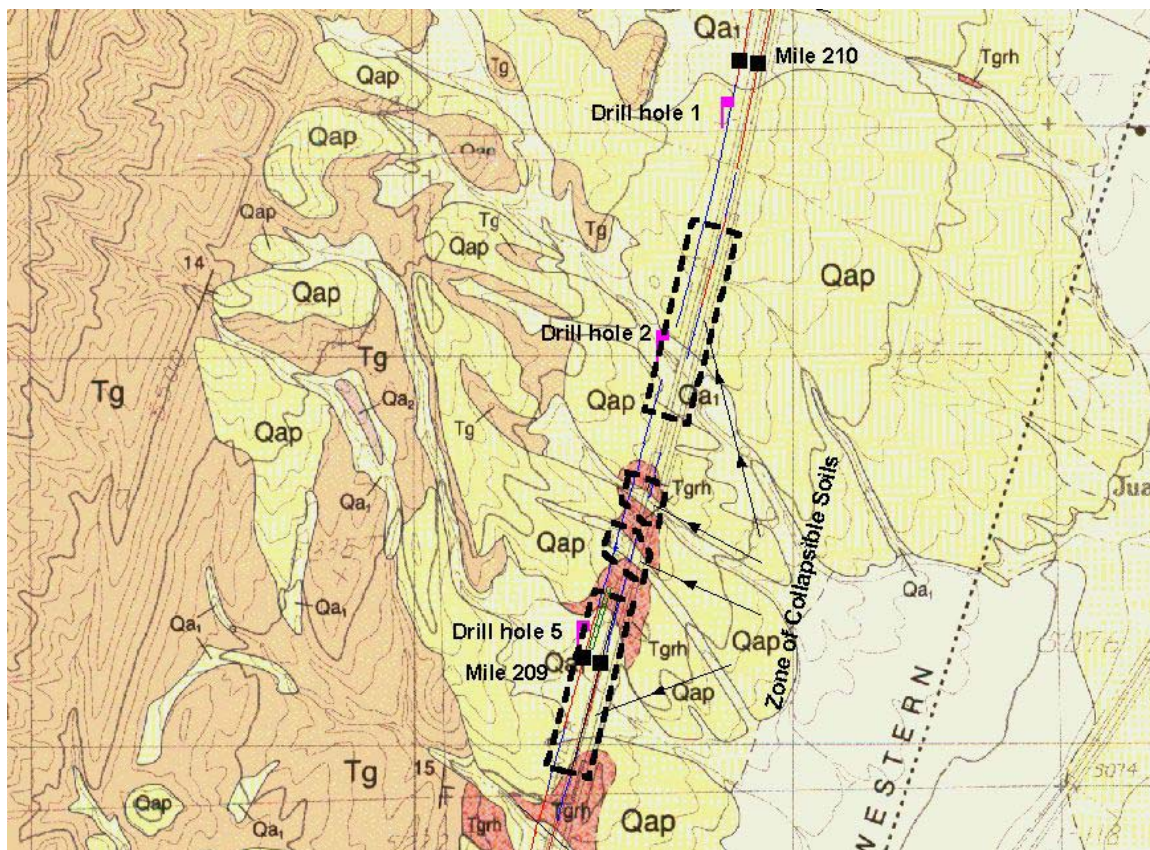
Figure 86: Map showing the four zones where collapsible soils have led to concentrated damage in the vicinity of milepost 209 and test holes 2 and 5. Lithology in the drainage basins upstream from the alluvial fans is conducive to the formation of collapsible soil.

Because the zone of collapsible soil extended to depths of up to 20 ft below the ground surface, deep dynamic compaction was recommended over excavation and replacement as a treatment method in these zones. Deep dynamic compaction has been employed with success in treating collapsible soil problems below interstate highways in New Mexico, Wyoming and Montana. This in-situ treatment method is one of the most economical soil improvement methods available (approximately \$1 to \$1.20 square foot of surface area) Recommendations for drop weight and height, energy per surface area, drop spacing and number of drops are presented in the body of the report. *After dynamic compaction every effort should be made to minimize water infiltration due to ponding at culverts and within other surface drainage features.*

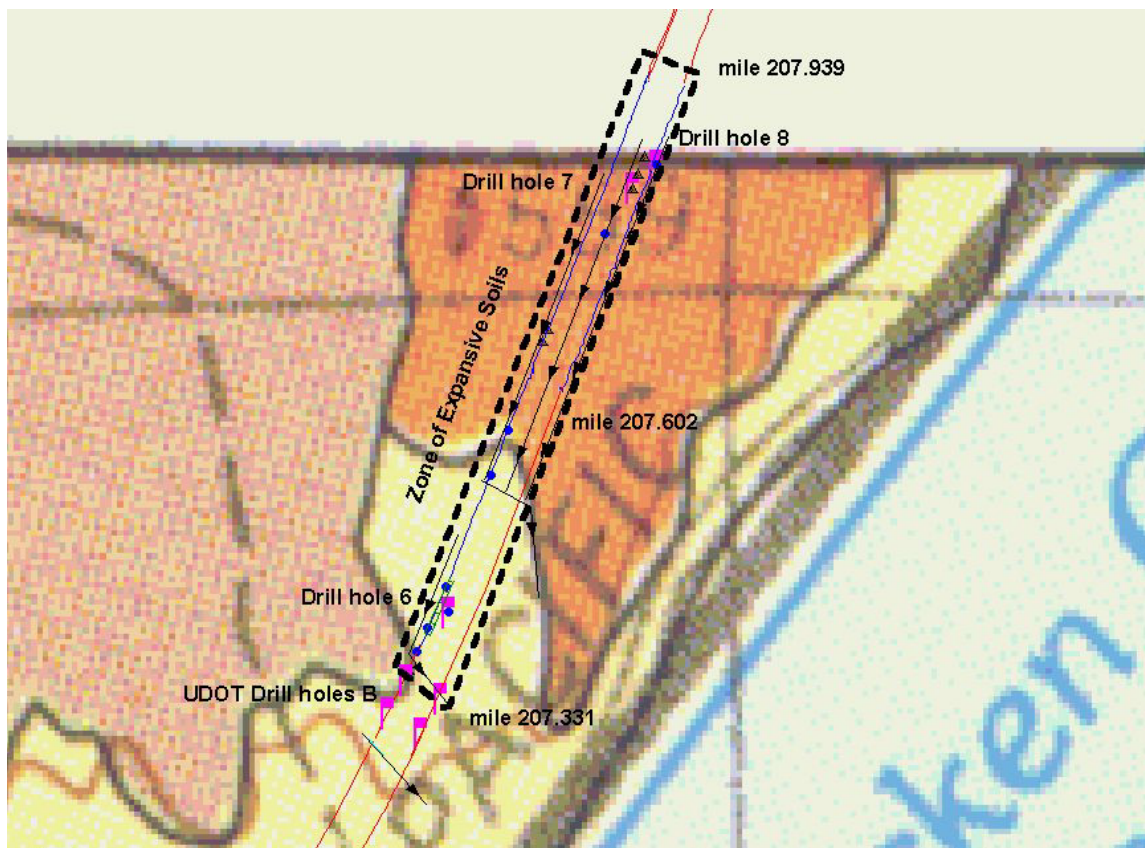
Figure 89: Expansive soil zone proposed for treatment and the distress features throughout the cut section between mileposts 208 and 207 along I-15, Juab County, Utah.

A number of options for treating expansive soils are available; however, no single method has proven foolproof in practice. This study recommends a combination of methods as illustrated in Figure ES-3 to improve the odds of success. First, we recommend excavation of three feet of the expansive material and recompaction with the same soil treated with 5% lime. Laboratory tests indicate that lime treatment will significantly reduce the plasticity of the clay (from PI of 70 in untreated to 17 in treated soil) and increase the CBR (from about 5 in untreated to 50 in treated soil). Second, we recommend a continuous rubber asphalt layer which would extend under the drainage ditches on either side of the interstate. This layer would prevent infiltration of water into the subgrade which has occurred with the current surface drainage system. This impervious layer would need to be covered with a six inch layer of soil to protect it from damage. Finally, we recommend that the base courses be placed above the liner and that an asphalt wearing surface be used rather than concrete to minimize the potential for cracking.
